Nassau County Stormwater Management Program

TIFFANY BROOK SUBWATERSHED STORMWATER RUNOFF IMPACT ANALYSIS AND CANDIDATE SITE ASSESSMENT REPORT

FINAL – October 1, 2007

CASHIN ASSOCIATES, P.C.
Engineering • Planning • Construction Management

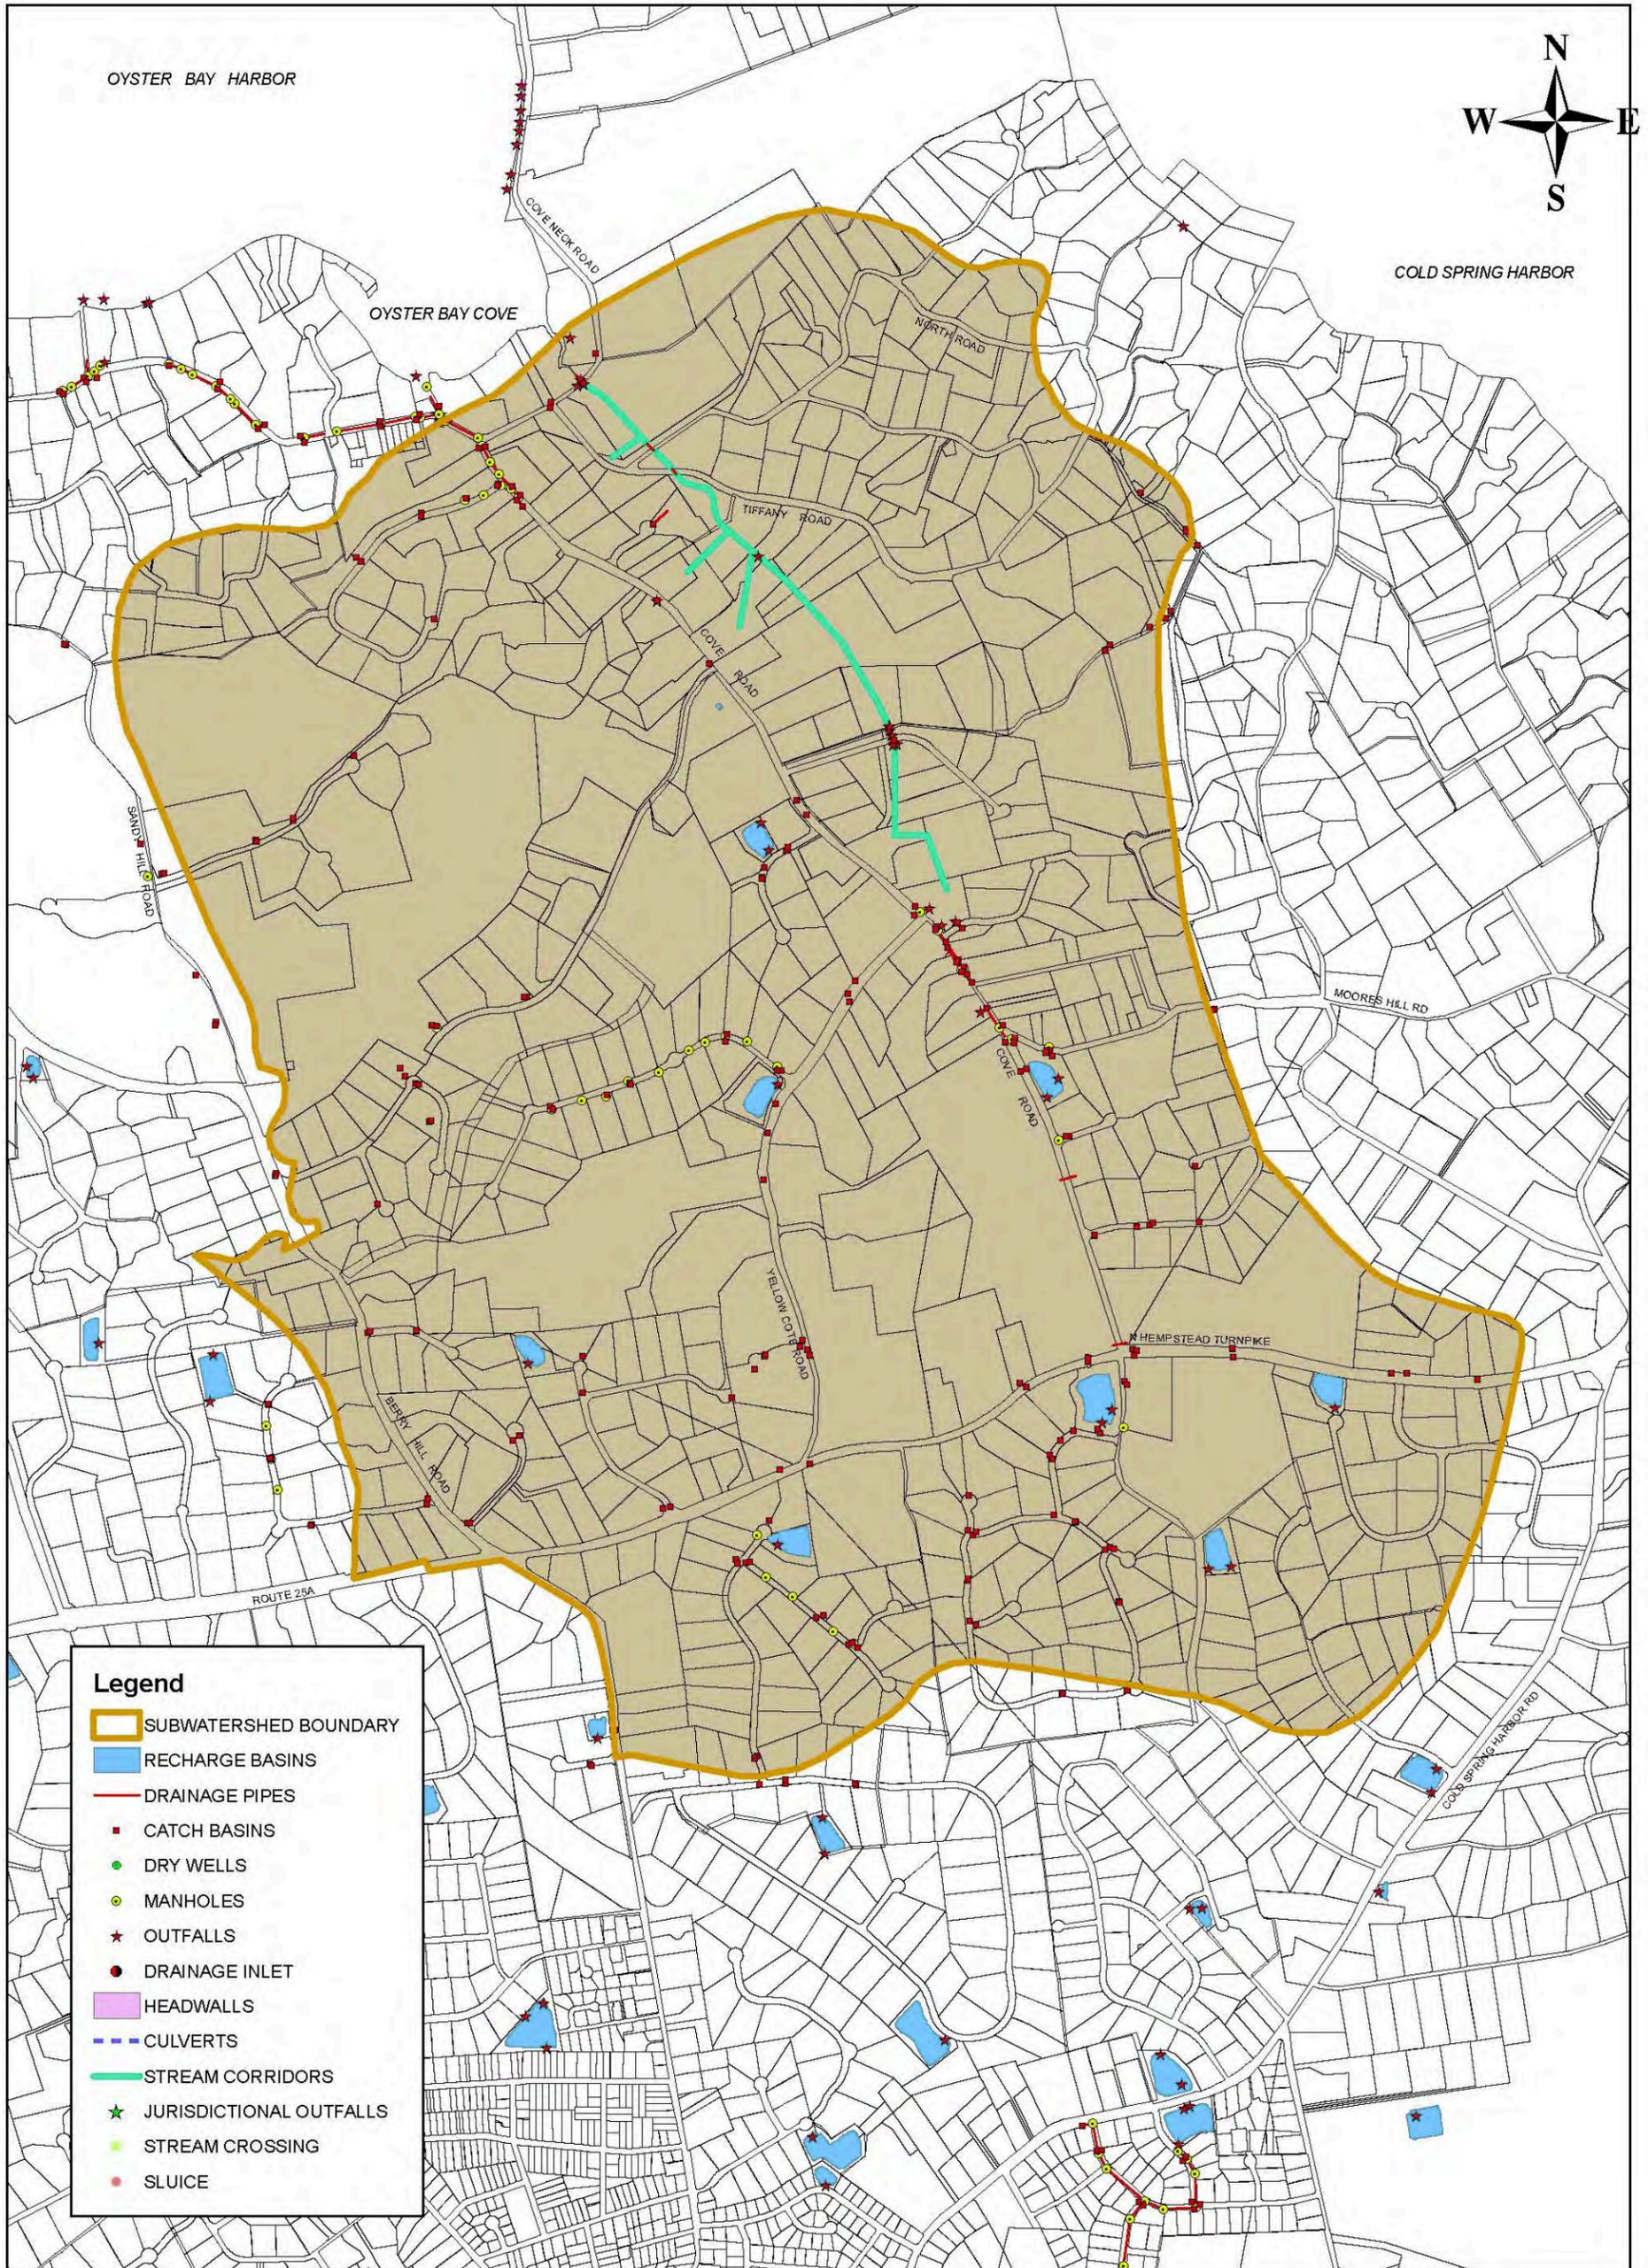
MAP 2-1
NASSAU COUNTY STORMWATER
MANAGEMENT PROGRAM
STORMWATER RUNOFF IMPACT ANALYSIS
DRAINAGE INFRASTRUCTURE
TIFFANY BROOK SUBWATERSHED

Using the mapping developed in Section 2.1.1, areas with incomplete drainage mapping were identified. A field survey of the drainage infrastructure in those locations was conducted. This task was performed in conjunction with the Stream Assessment described in Section 2.3. During the assessment, the stream corridor was walked to verify the mapped outfalls and to identify other locations where storm runoff appeared to be directly entering the stream. The drainage infrastructure upstream of each outfall was then field verified to identify the extent of the drainage infrastructure contributing to each outfall. The drainage infrastructure of the Tiffany Brook subwatershed is shown on Map 2-1.

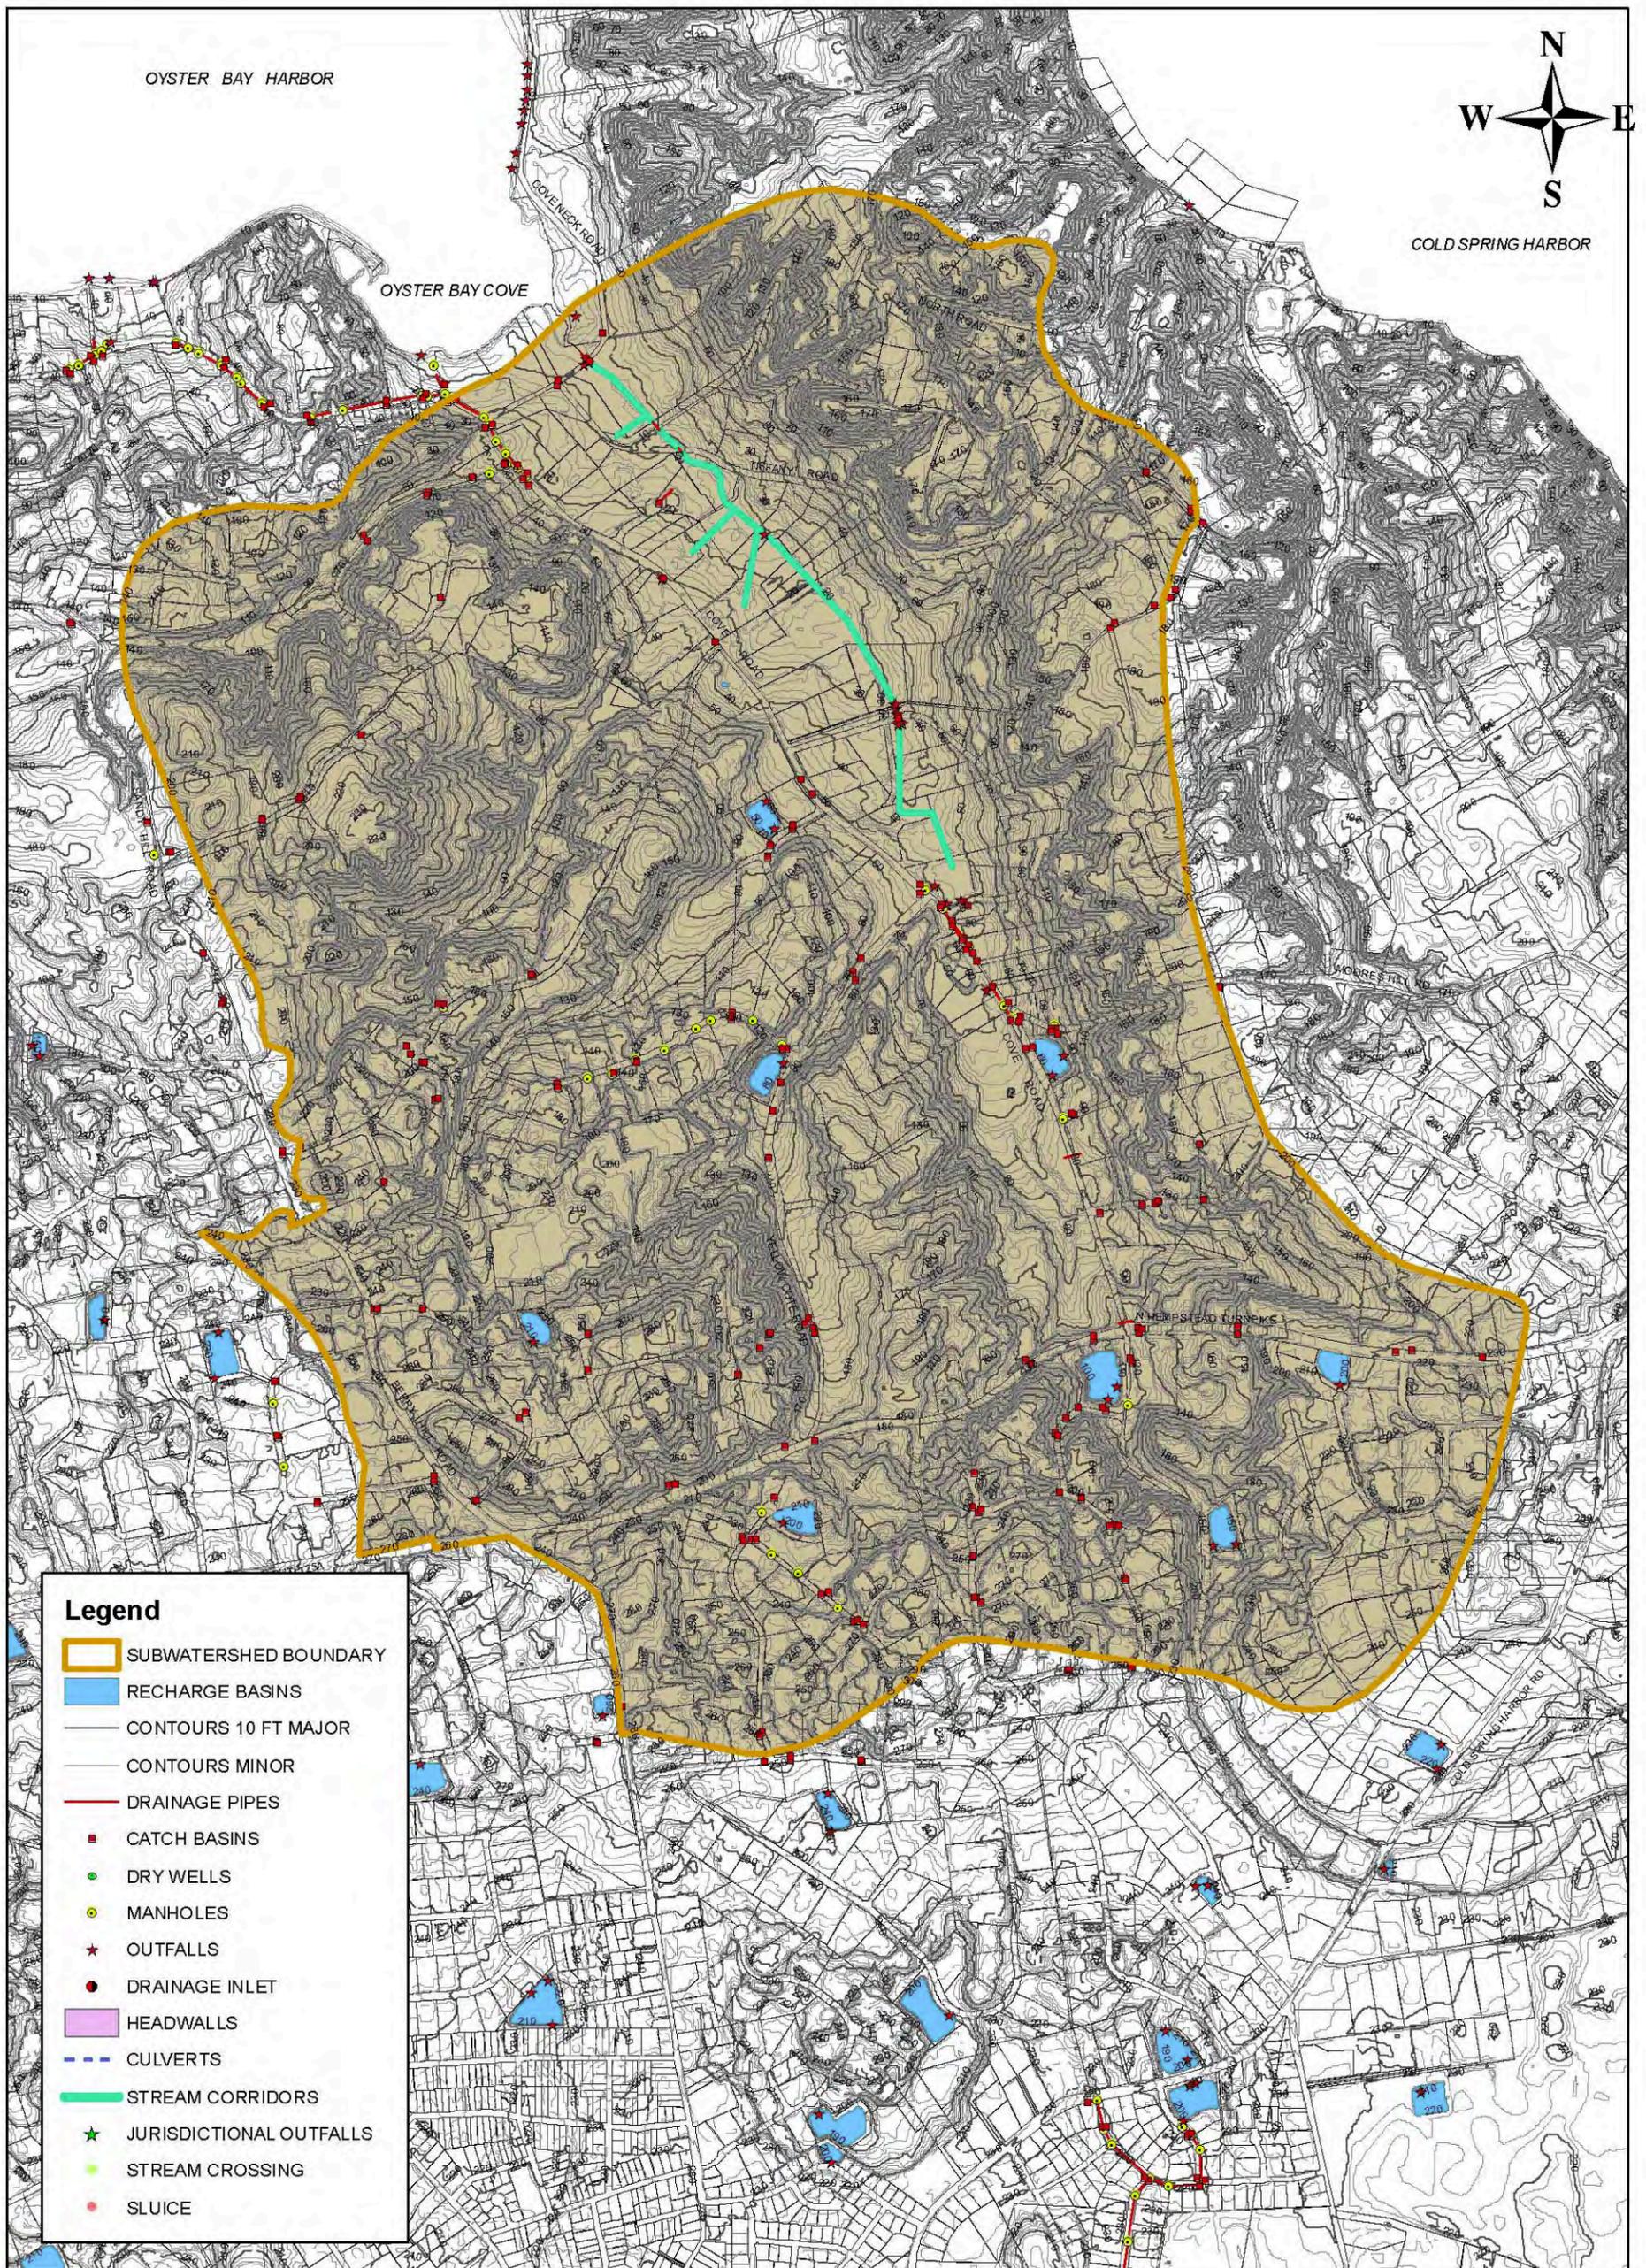
MAP 2-2
 NASSAU COUNTY STORMWATER
 MANAGEMENT PROGRAM
 STORMWATER RUNOFF IMPACT ANALYSIS
 CONTOURS
 TIFFANY BROOK SUBWATERSHED

The geographic limits of the Tiffany Brook subwatershed were defined through review of topographic maps, plans of existing municipal drainage infrastructure, and field assessment. Map 2-2 shows subwatershed topography along with existing drainage infrastructure.

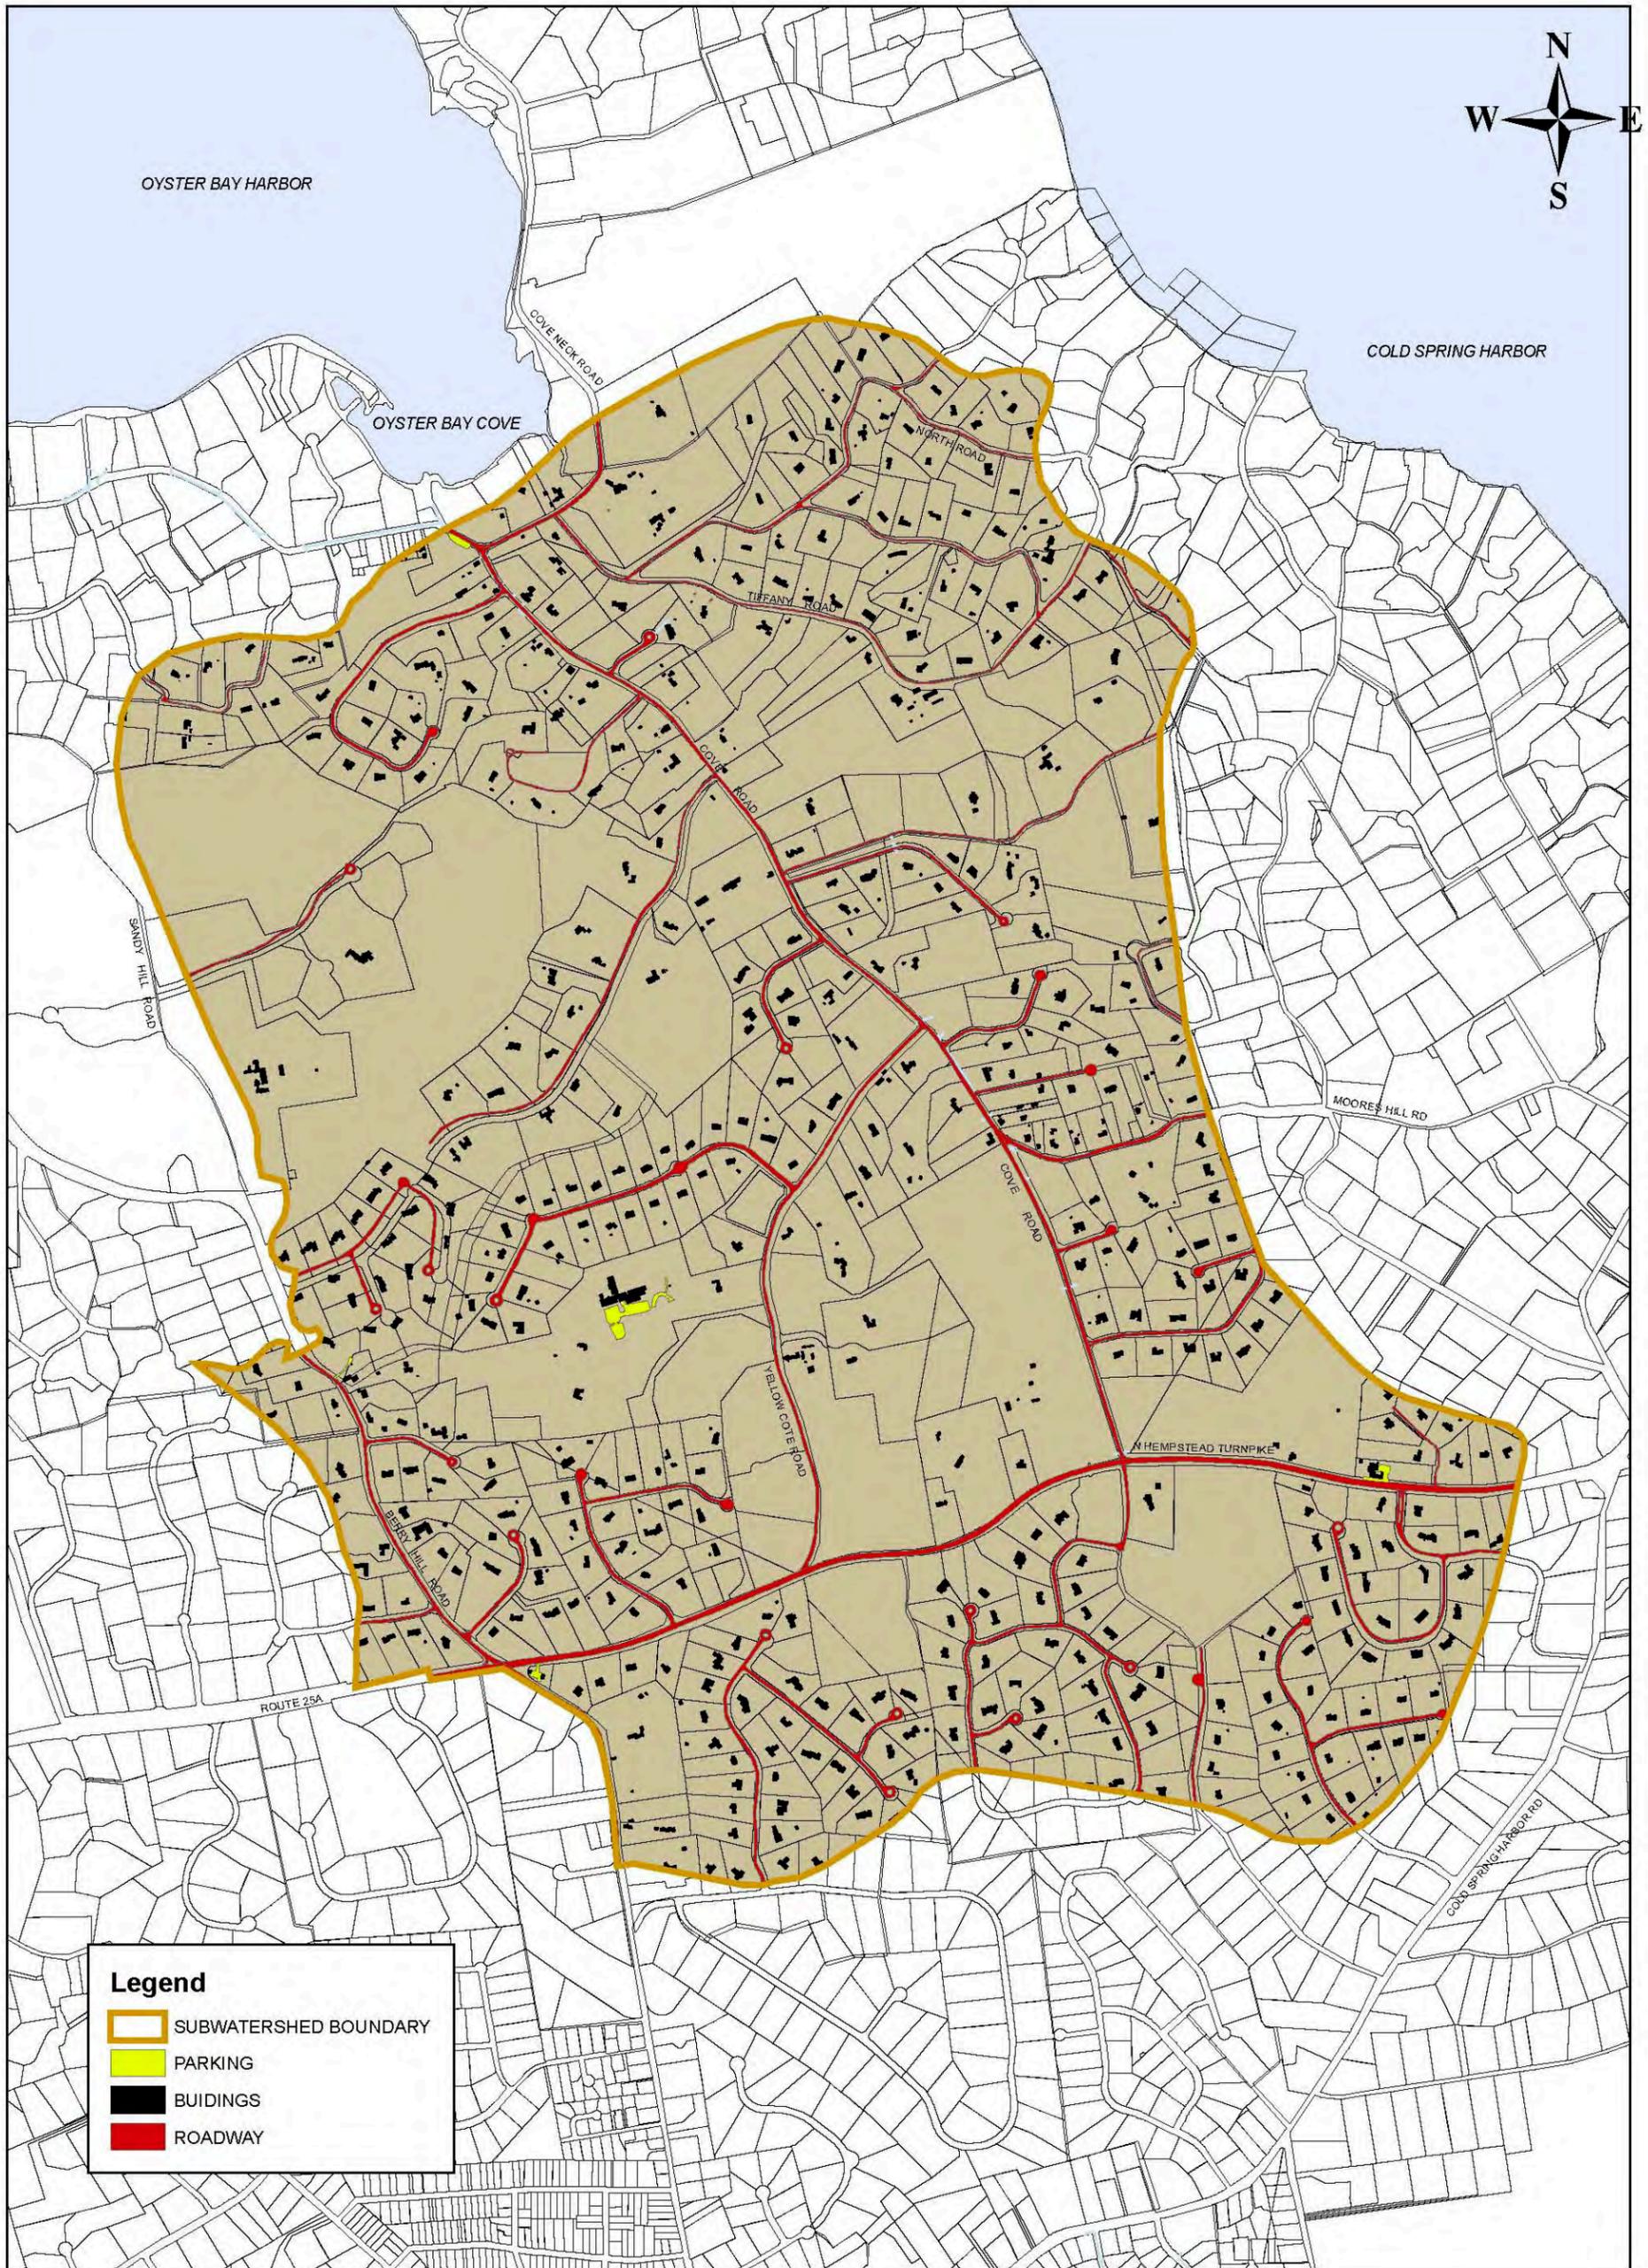
MAP 2-3
NASSAU COUNTY STORMWATER
MANAGEMENT PROGRAM
STORMWATER RUNOFF IMPACT ANALYSIS
IMPERVIOUS AREAS
TIFFANY BROOK SUBWATERSHED

The impervious cover data was entered into the standard table from the Procedures Manual. The data table and results of calculations are shown on Table 2-3. The impervious area of the Tiffany Brook subwatershed is 115 acres of the 1,894 total subwatershed acres. This represents 6% of the subwatershed. Based on the 6% impervious figure, Tiffany Brook receives a subwatershed classification of sensitive stream.

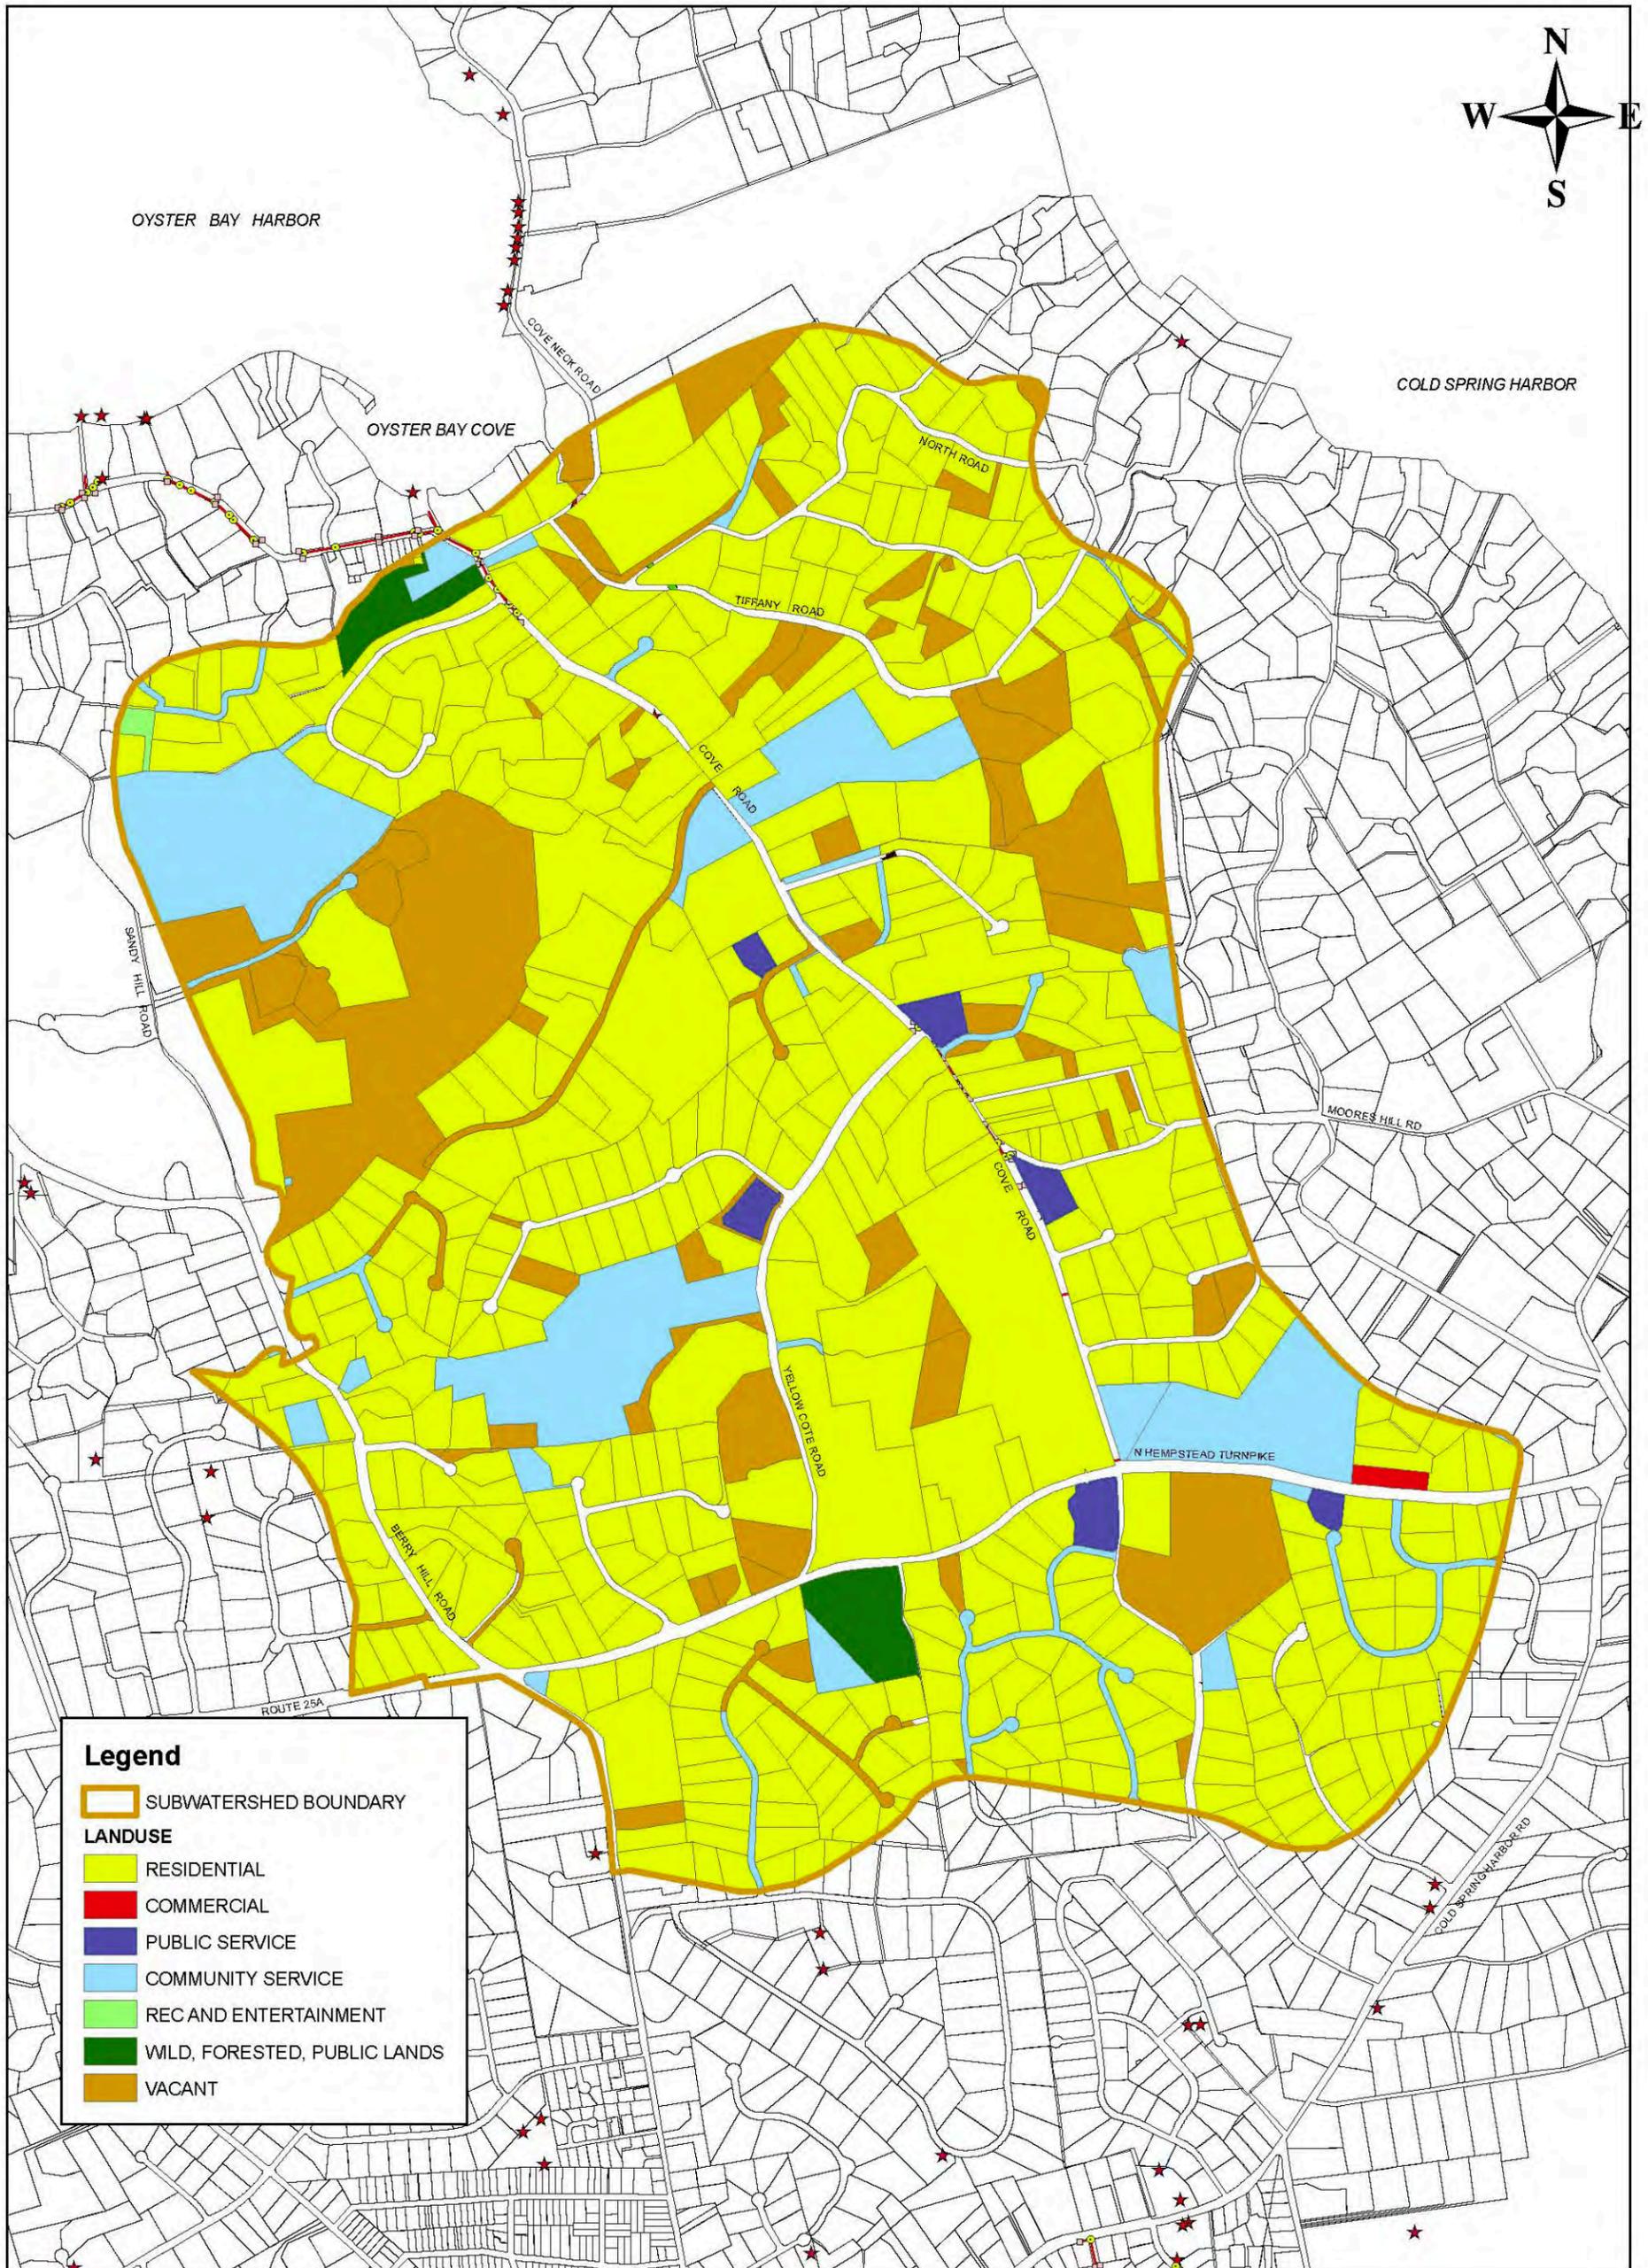
MAP 2-4
NASSAU COUNTY STORMWATER
MANAGEMENT PROGRAM
STORMWATER RUNOFF IMPACT ANALYSIS
LANDUSE
TIFFANY BROOK SUBWATERSHED

Land use within the subwatershed is comprised mostly of residential areas. The subwatershed is 71% residential and 26% other (parks, municipal, etc.). Of the 533 residences in the subwatershed, 476 or 89% are larger than one acre in size.

the runoff. Map 2-4 Land Use identifies numerous vacant parcels in the subwatershed. Those located along roads or close to the brook offer the greatest opportunity to capture pollutants prior to flowing into the brook.

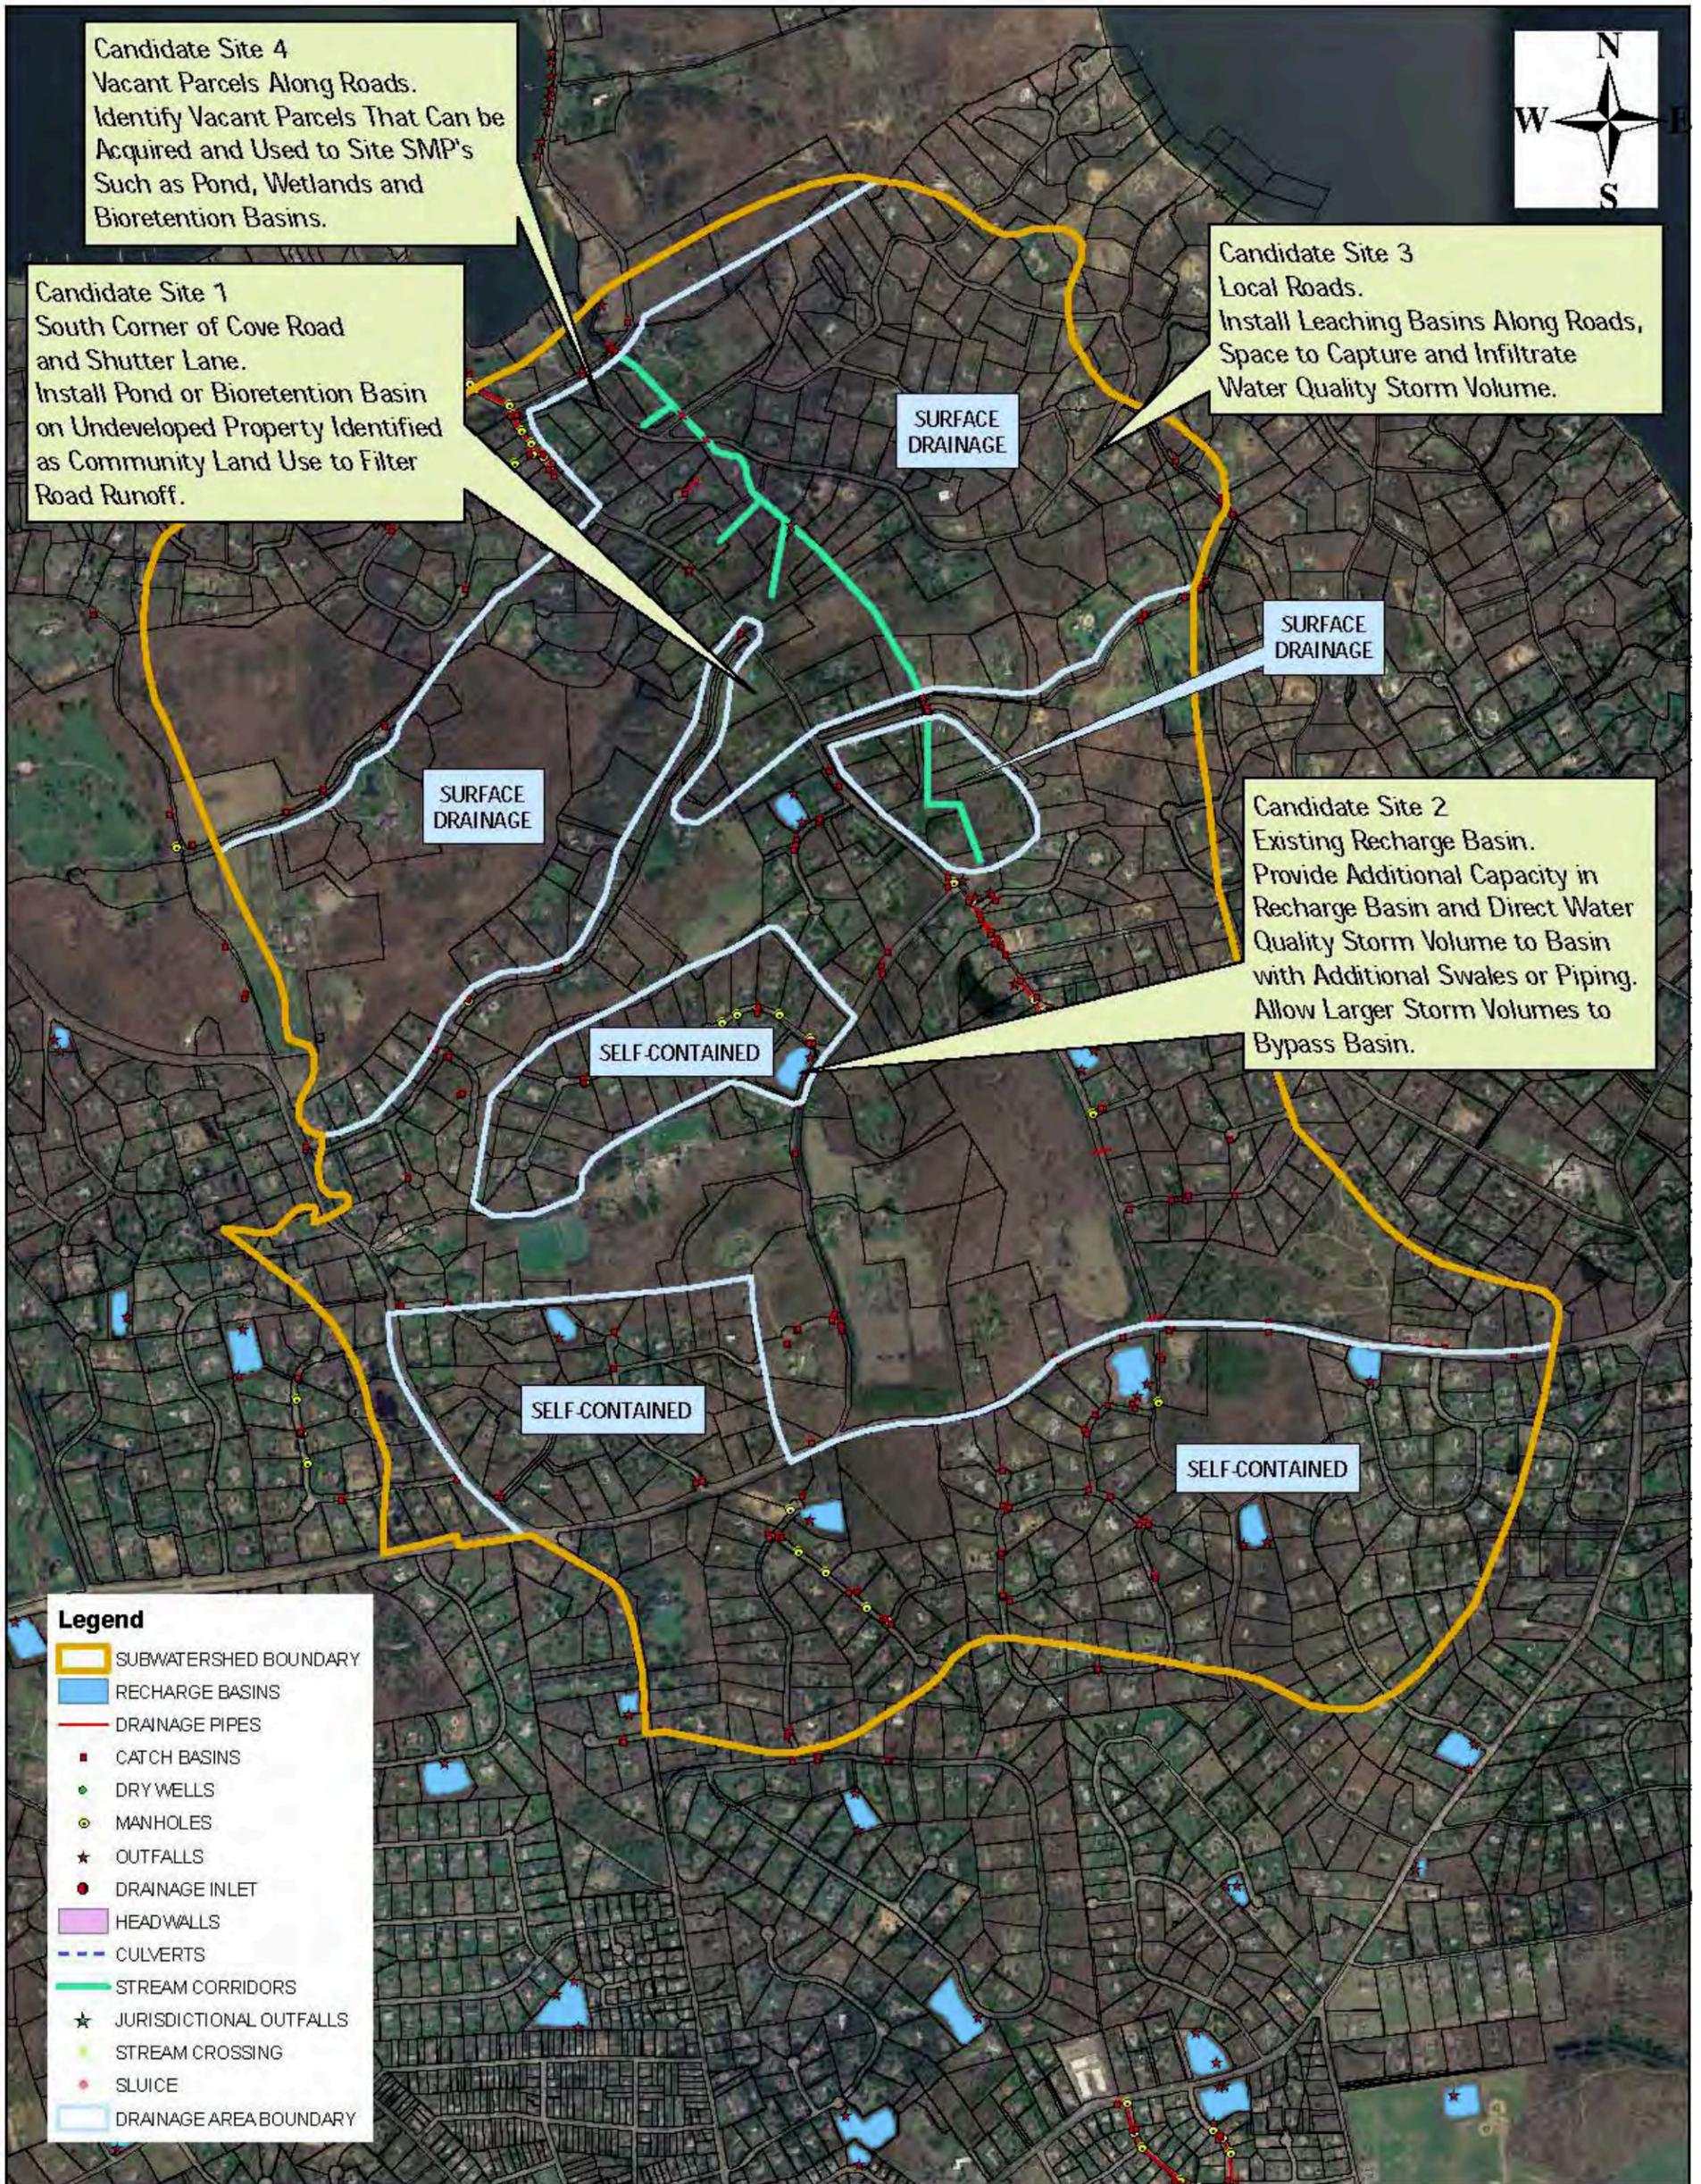
Candidate Site 4
 Vacant Parcels Along Roads.
 Identify Vacant Parcels That Can be Acquired and Used to Site SMP's Such as Pond, Wetlands and Bioretention Basins.

Candidate Site 1
 South Corner of Cove Road and Shutter Lane.
 Install Pond or Bioretention Basin on Undeveloped Property Identified as Community Land Use to Filter Road Runoff.

Candidate Site 3
 Local Roads.
 Install Leaching Basins Along Roads, Space to Capture and Infiltrate Water Quality Storm Volume.

The Tiffany Brook subwatershed has several potential parcels that could be used to site SMP's that would reduce pollutant loads into Tiffany Brook. The proposed candidate sites and the SMPs discussed herein are shown on Map 3-1 Candidate Sites Map.

Candidate Site 1 is the parcel located on the south corner of Cove Road and Shutter Lane. This parcel is denoted as a community service land use and appears to be underdeveloped with a large amount of open area. This location offers the opportunity to site a bioretention basin that would detain and filter the water quality storm volume. Larger flows would continue to flow directly into the brook.

Candidate Site 2 identifies the existing recharge basin as offering opportunity to provide additional storage capacity. Expansion of the recharge basin can be used to provide storage volume of the water quality storm runoff from additional portions of the subwatershed. Larger stormwater volume from the expanded areas would continue to bypass these recharge basins.

Candidate Site 3 identifies the opportunity to install leaching basins that would capture and infiltrate runoff or vegetated swales that would filter runoff along roads that drain toward the brook.

Candidate Site 4 identifies the opportunity to locate vacant parcels that can be acquired and used to site SMP's such as ponds, wetlands, and bioretention basins that would filter
