PHASE I ENVIRONMENTAL SITE ASSESSMENT

SANDS NEW YORK
1255 Hempstead Turnpike
Uniondale, New York

Langan Engineering, Environmental, Surveying, Landscape Architecture and Geology, D.P.C.
360 West 31st Street, 8th Floor
New York, New York 10001

May 15, 2023
Phase I Viability End Date – August 1, 2023
170754501

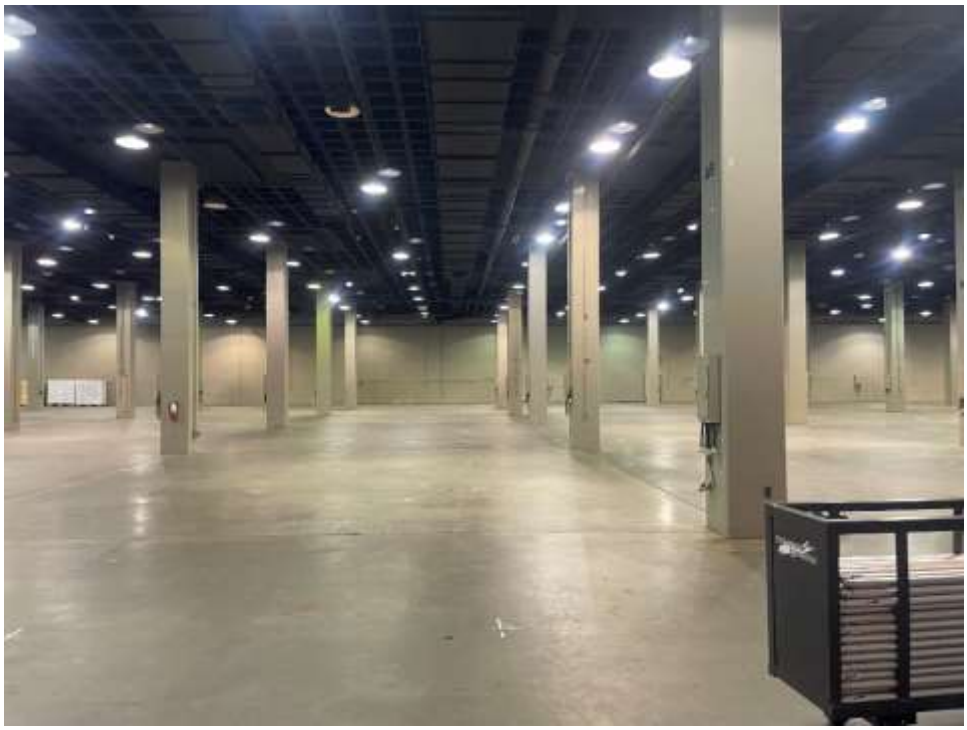
Photograph 4 – General view of subgrade event level space of the Subject Property, facing north.

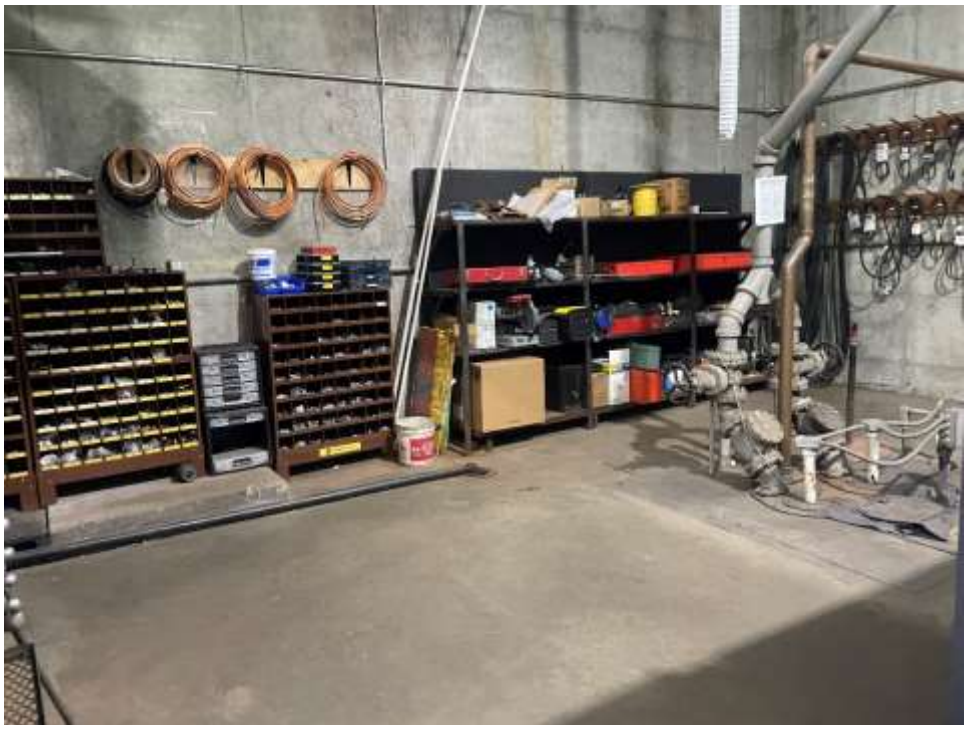
Photograph 5 – General view of a mechanical room and sump pit at the Subject Property, facing northeast.

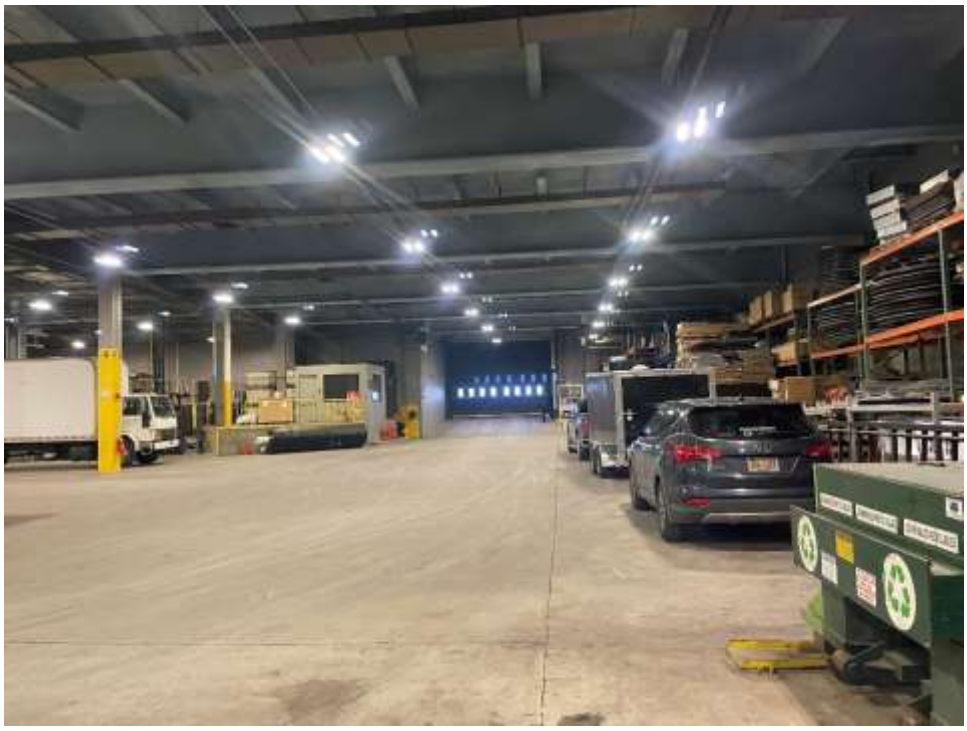
Photograph 11 – Loading dock area and entrance ramp, facing west.

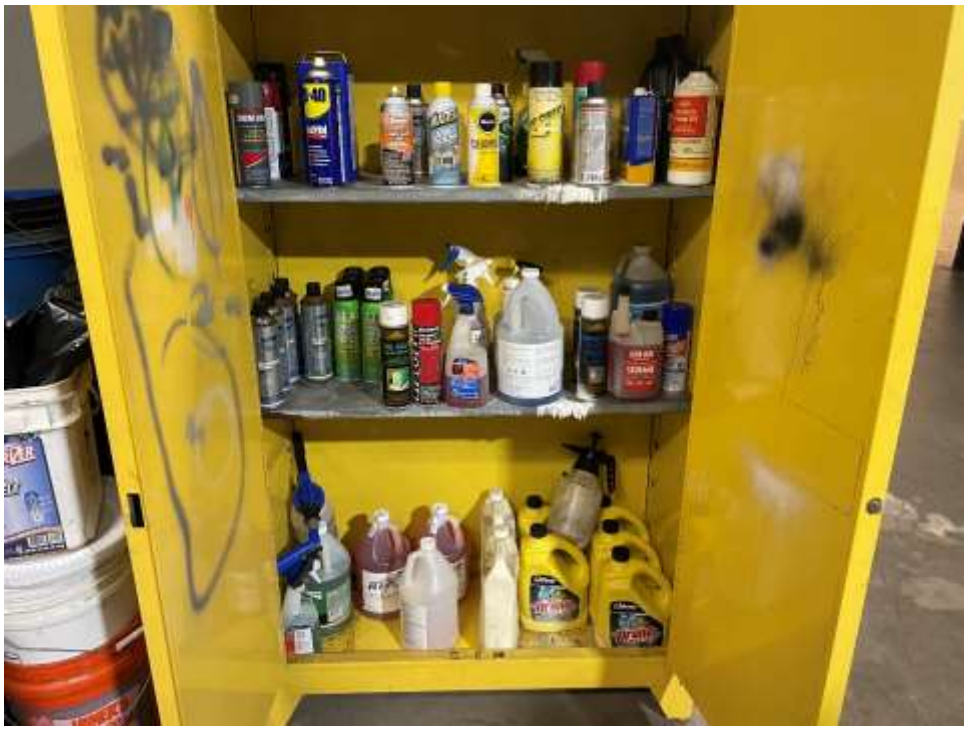
Photograph 14 – Chemical storage at the Subject Property, facing south.

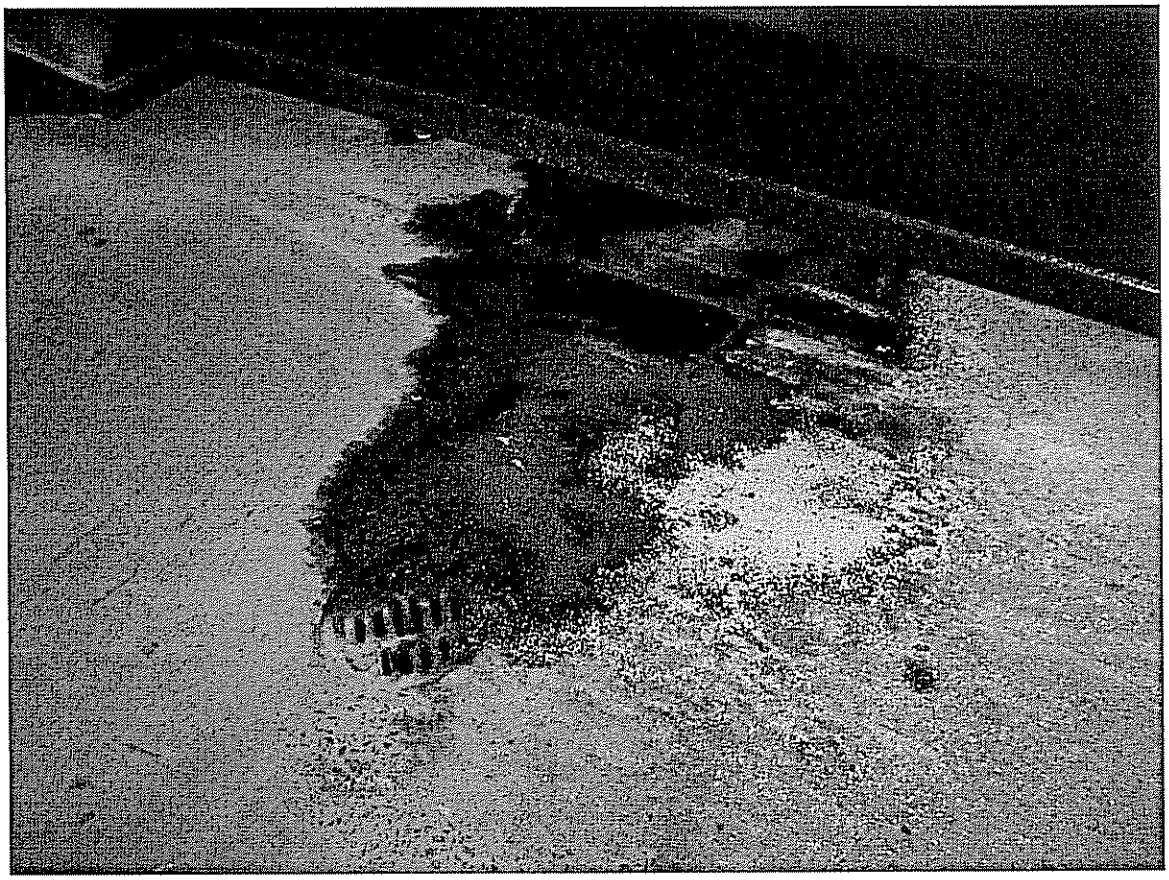
Photograph No. 8: Visually impacted loading bay drain.

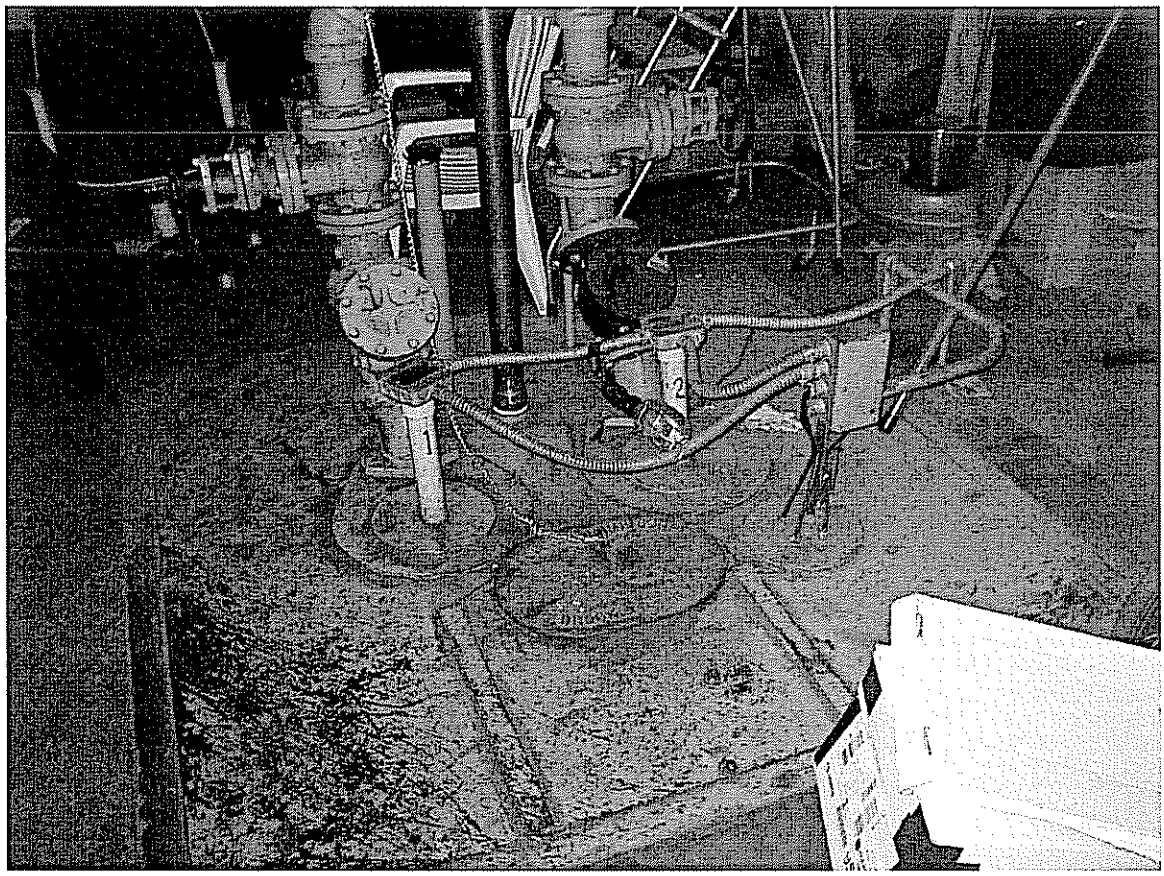
A sewer ejector pit was observed at the northeastern portion of the truck loading bay and reportedly discharges material from the interior floor drains within the building to the municipal sewer system (Photograph No. 9). A Zamboni machine, utilized to maintain the arena ice surface during events was staged proximate to the sewer-ejector pit. The Zamboni is fueled by compressed propane gas. According to the NCFM, only the cylinders being utilized by Zamboni are permitted to be stored within the building. Spare propane cylinders are required to be stored in a caged area located outside the Coliseum (observed at the north side of the loading bay entrance ramp, as discussed later).

Photograph No. 9: Representative sewer-ejector pit.

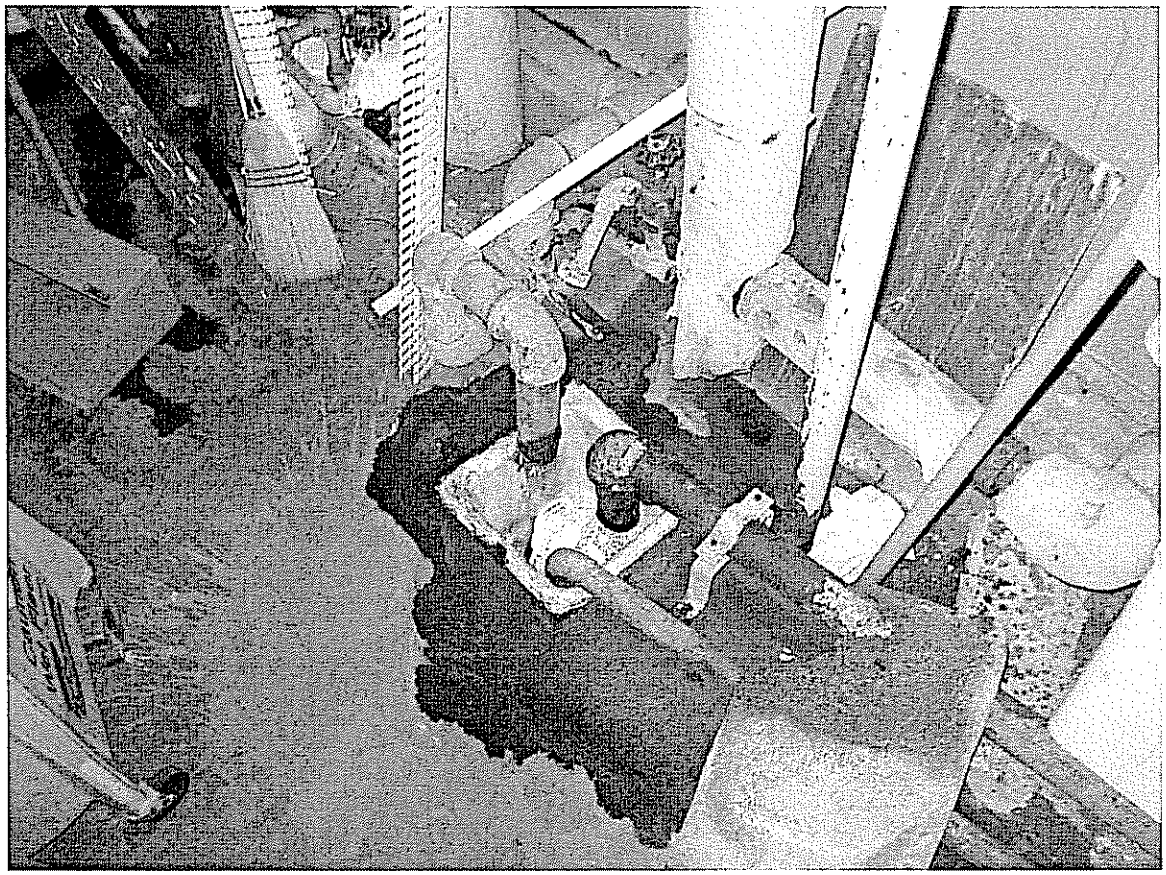
The mechanical area south of the Exhibition Hall includes an area utilized for a machine shop to support routine building repairs. This room was equipped with a slop sink which discharged to a hard-piped floor drain which reportedly discharges to one of the sewer ejector pits) (Photograph No. 10). Three 55-gallon waste oil drums, three 35-gallon oil drums and several five-gallon containers containing various oils and solvents were staged within this room (Photograph No. 11). Minor amounts of concrete-floor staining were observed proximate to the stored drums/containers. No floor drains appeared to be impacted by the staining. A second sewer-ejector pit (two of three on-site sewer-ejector pits) was located within the machine shop (see Photograph No. 9). According to Mr. Bizgia, the aforementioned sewer-ejector pits direct floor drain discharge to the municipal sewer system. However, this could not be confirmed during the site inspection.

Photograph No. 10: Hard-piped slop sink discharge point.

Photograph No. 11: **Three 55-gallon waste oil drums, three 35-gallon oil drums and several five-gallon containers containing various oils and solvents.**

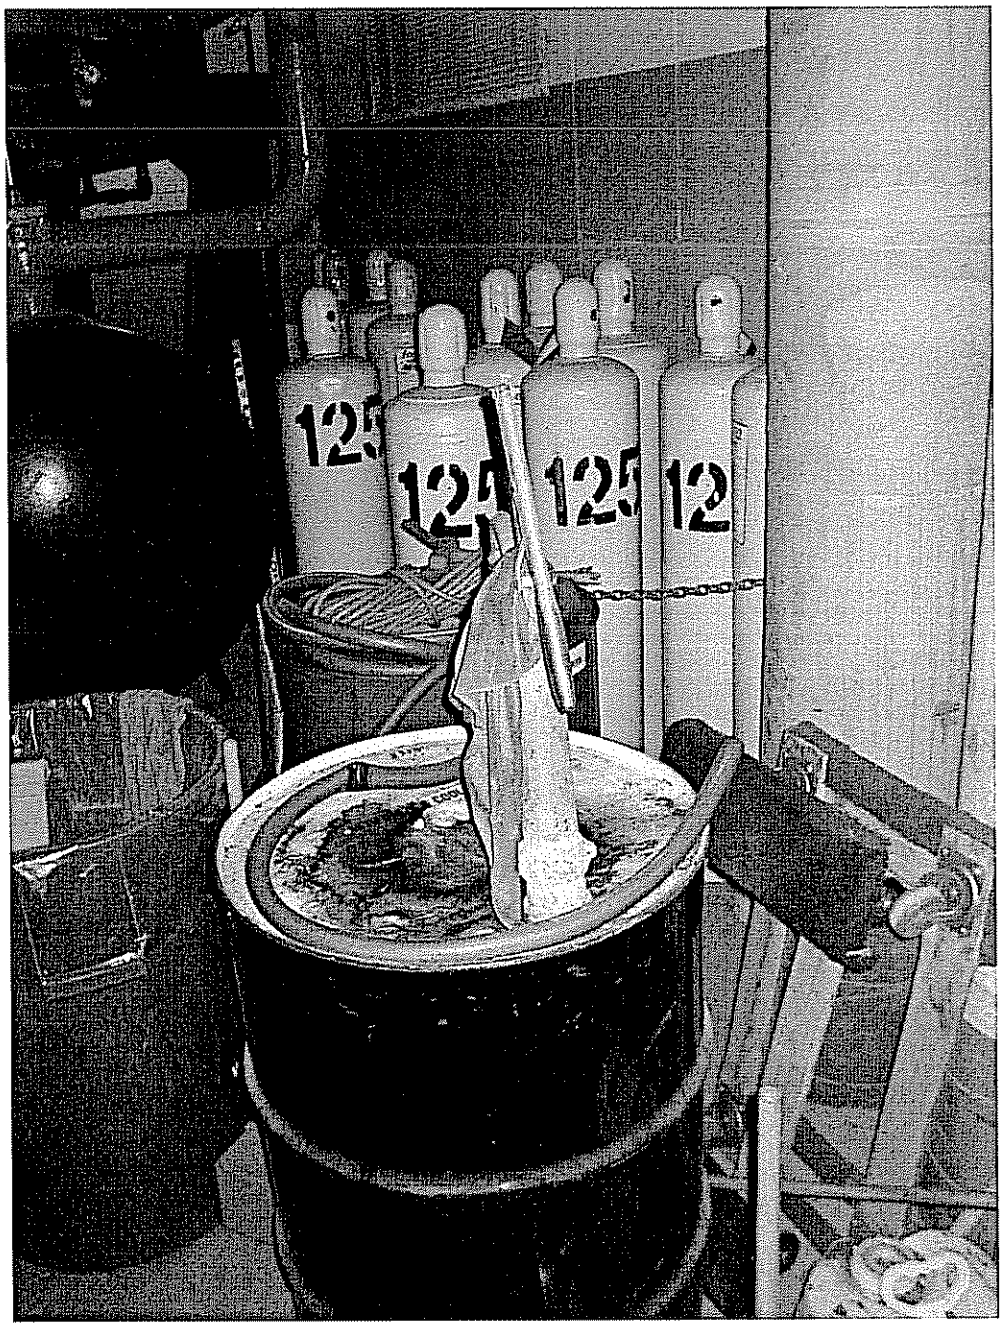
<u>Photograph No. 16:</u> Stored containers of R-22 (refrigerant) and a 55-gallon drum. The 6,000-pound freon AST is visible at the left side of the photograph.

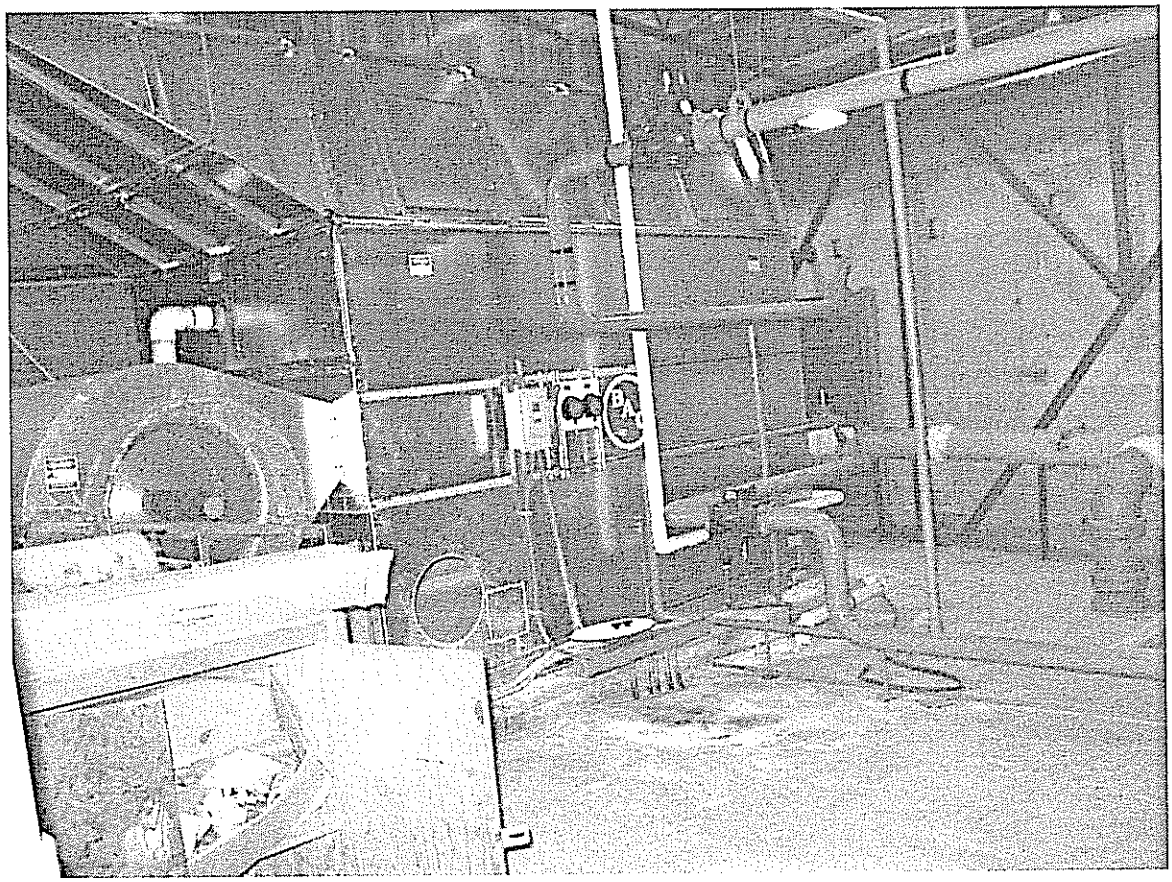
A closed-loop chiller unit was located north of the private boxes (Photograph No. 22). According to Mr. Bizgia, same had recently been replaced. Several small (e.g., less than or equal to five gallon) containers of water treatment chemicals (e.g., Aquasperse and Biosperse), as well as an out-of-service expansion tank, were situated within the chiller room (Photograph No. 23). As stated earlier, the heating and cooling systems for the facility are operated by a closed-loop system of hot and chilled water supplied by the off-site Trigen CUP. Pneumatically-driven damper air handling units associated with the heating/cooling system were observed within the mechanical area situated north of the chiller room.

Photograph No. 22: **Chiller unit.**

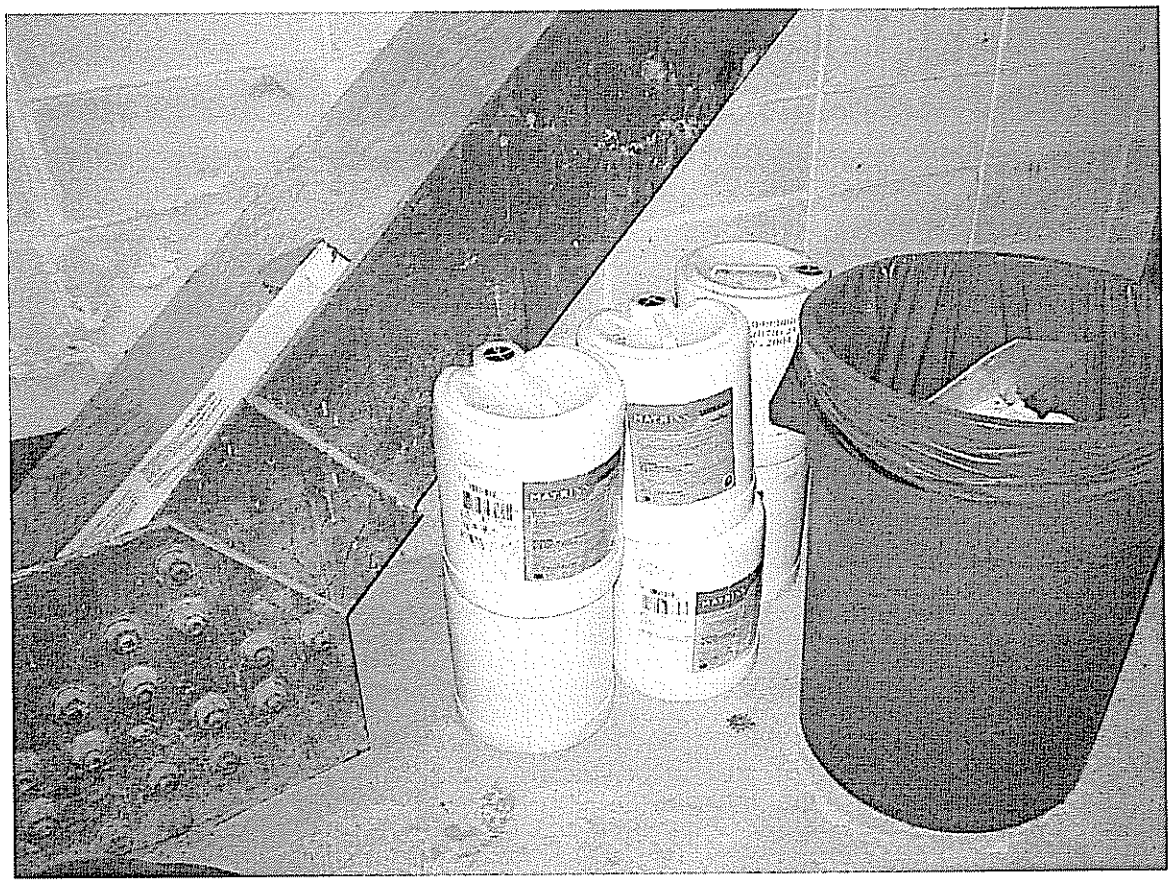
<u>Photograph No. 23:</u> Stored containers of water treatment chemicals.

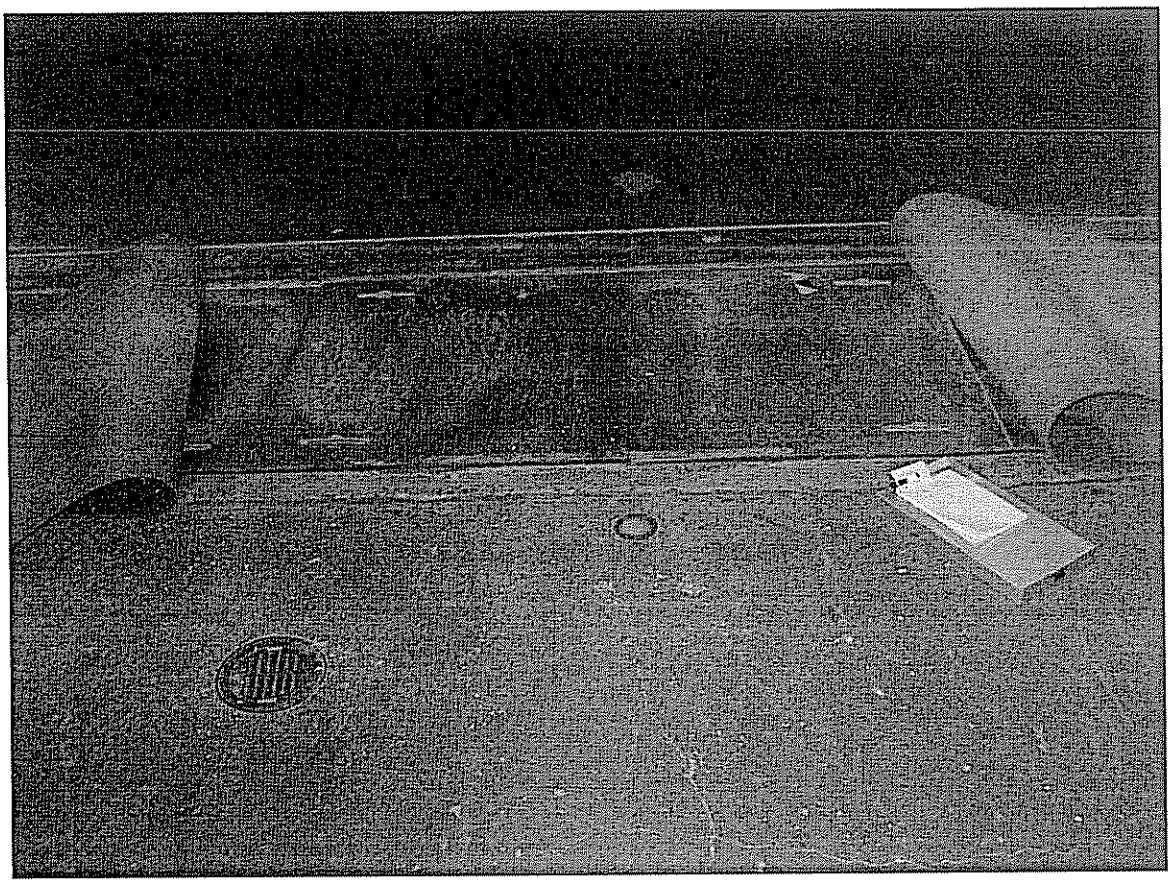
<u>Photograph No. 27:</u> Metal covers concealing the arena floor hard-piped trench drain.

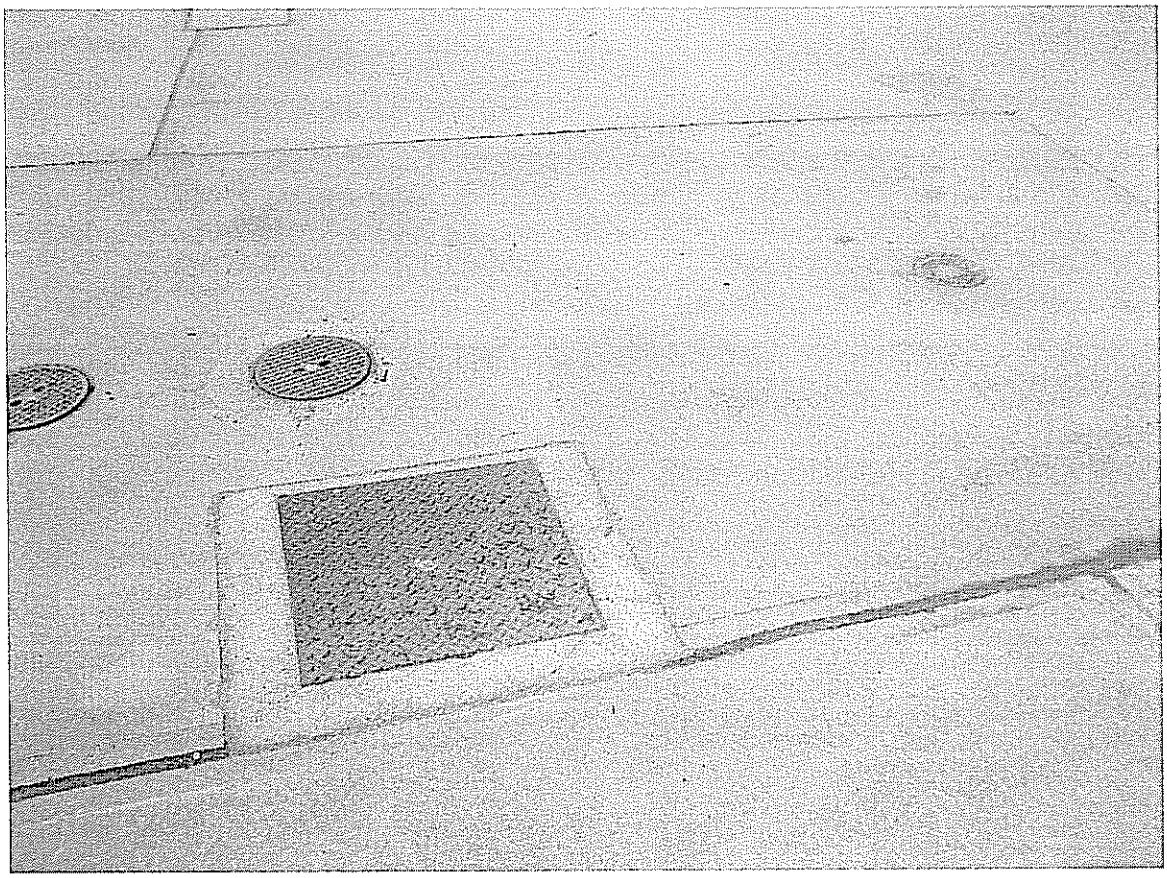
<u>Photograph No. 29:</u> Solid manhole cover and scarring associated with asphalt-repairs.

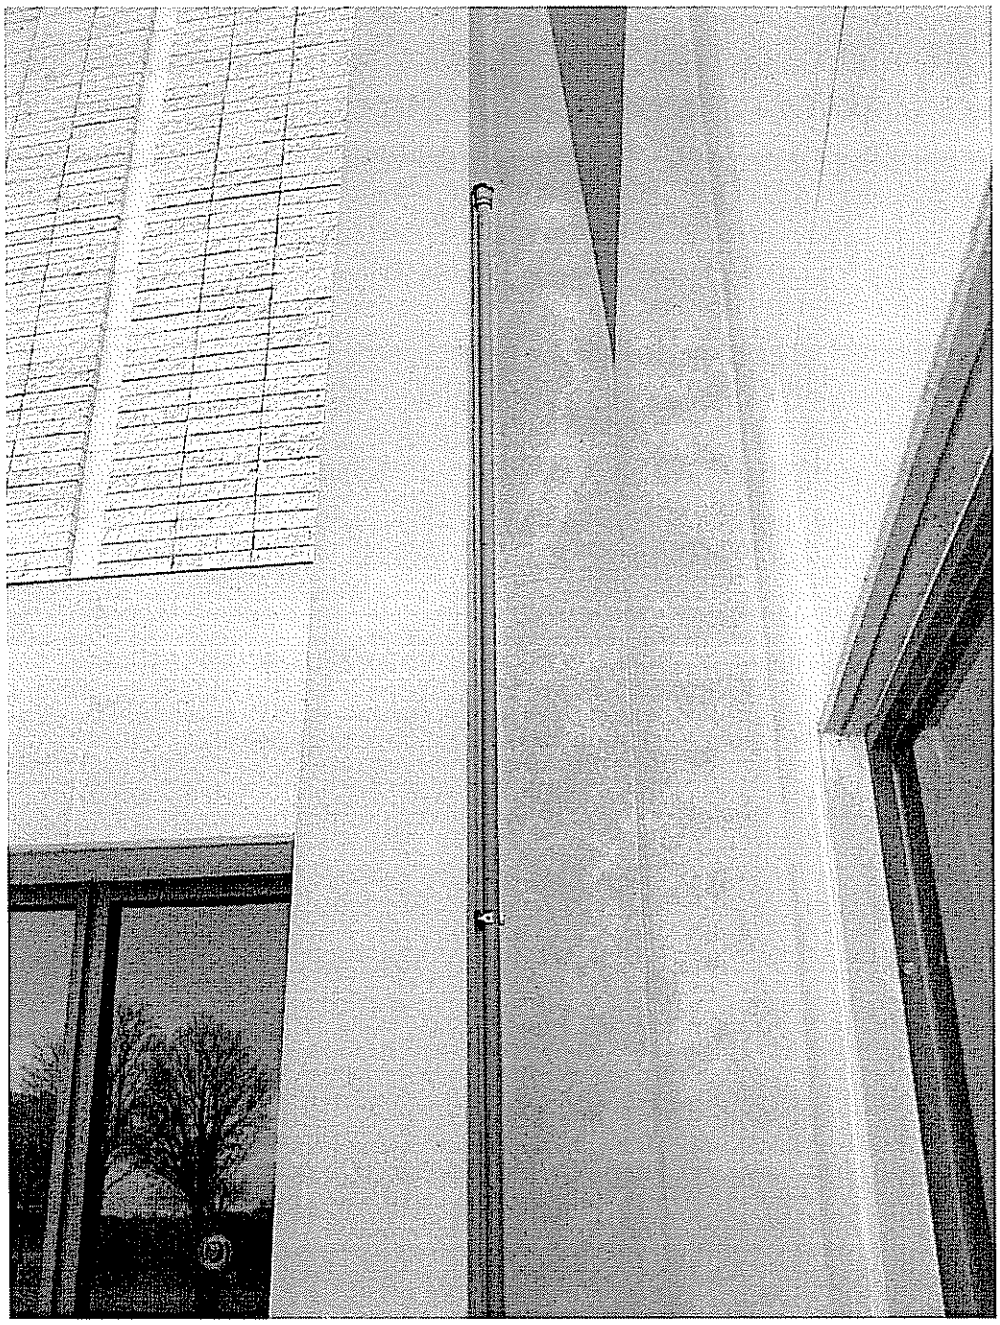
Photograph No. 31: Vent pipe associated with a reportedly 1,000-gallon diesel UST.

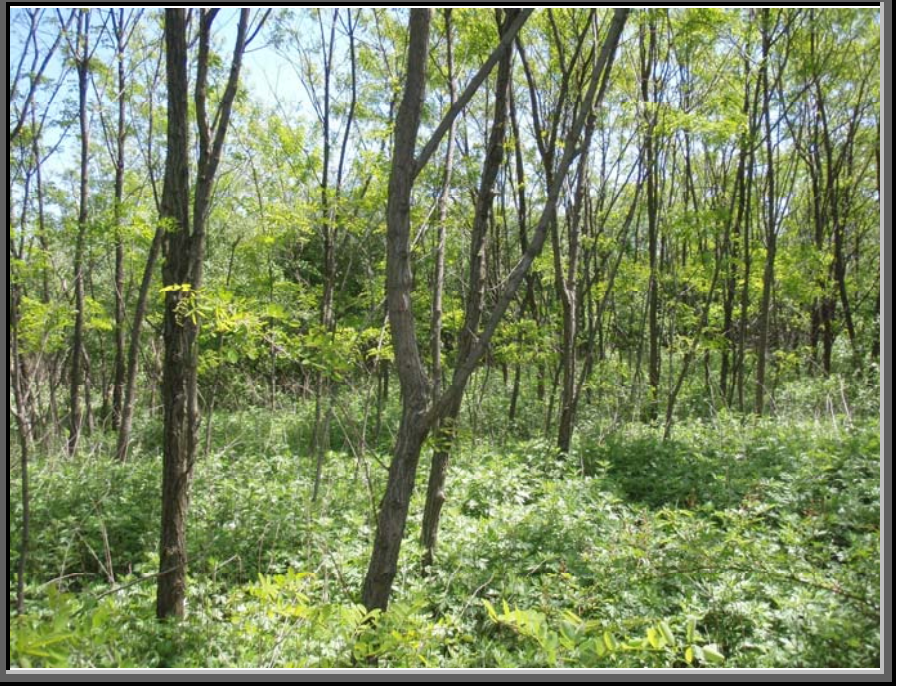
Photograph No.: E.9 Date: 05/19/09 Time: 12:01

Site:	Mitchel Field
Photographer:	B. Claus
Location of Photograph:	MRS 5- Machine Gun Range
GPS Coordinates: (UTM Zone 19N)	N 4524319.798 E 610105.099
Direction of Photo:	West
Comments:	View of the approximate location of the former firing point at MRS 5
